INSPECTION REPORT

For the Property at:
3 CAMBRIDGE DR
CANTERBURY, NH 03224

Prepared for: JAMIE DURAND
Inspection Date: Wednesday, January 11, 2012
Prepared by: Jamie Durand

RE: Report No. 1007, v.0
3 Cambridge dr
Canterbury, NH
03224

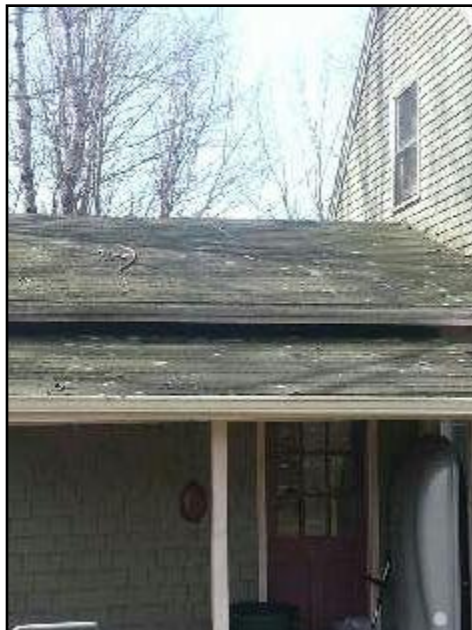
2. Condition: • [Near end of life expectancy](#)

The garage roofing is near the end of its life expectancy.

Implication(s): Chance of water damage to contents, finishes and/or structure

1. Near end of life expectancy

Task: Further evaluation replace

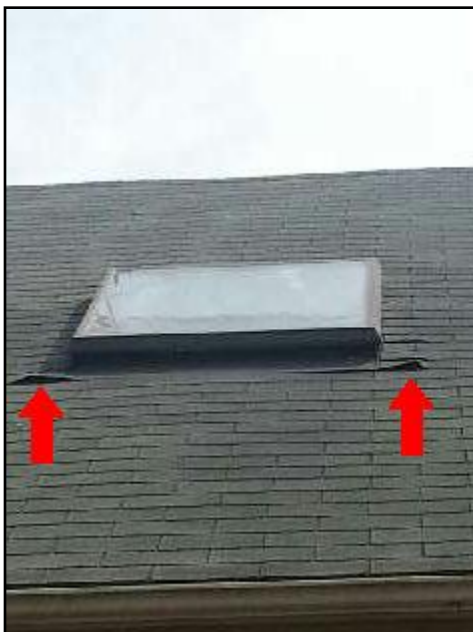
3. Condition: • [Cupping, curling, clawing](#)

Implication(s): Chance of water damage to contents, finishes and/or structure

2. Cupping, curling, clawing

Task: Further evaluation

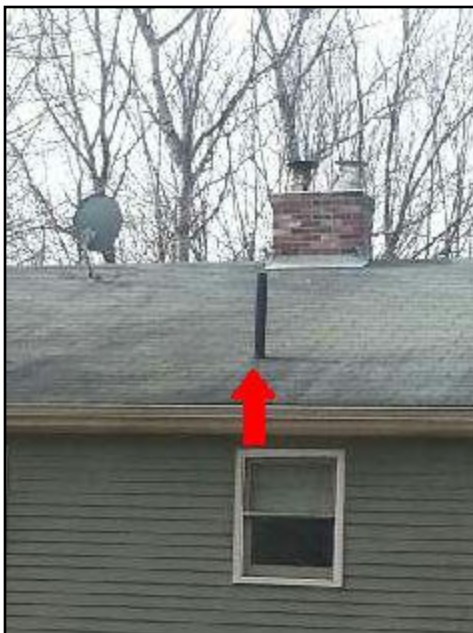
4. Condition: • Top of flashing exposed or bottom buried

The bottom of the pipe flashing should not be shingled over.

Implication(s): Chance of water damage to contents, finishes and/or structure

3. Top of flashing exposed or bottom buried

Task: Monitor

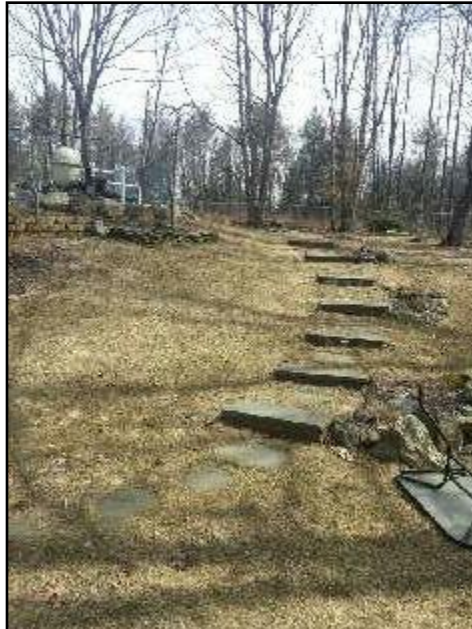
• [Towards house](#)

4. Towards house

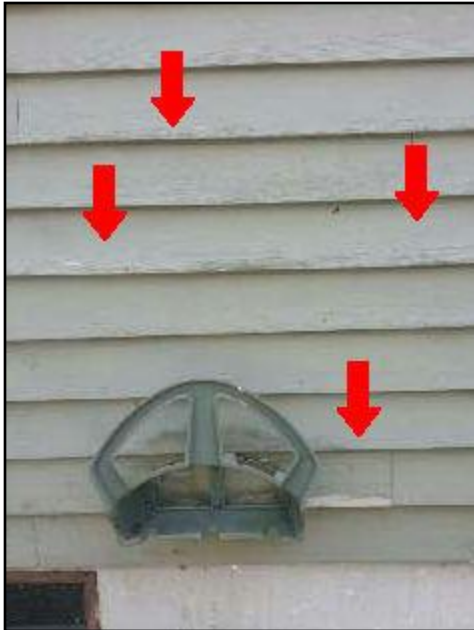
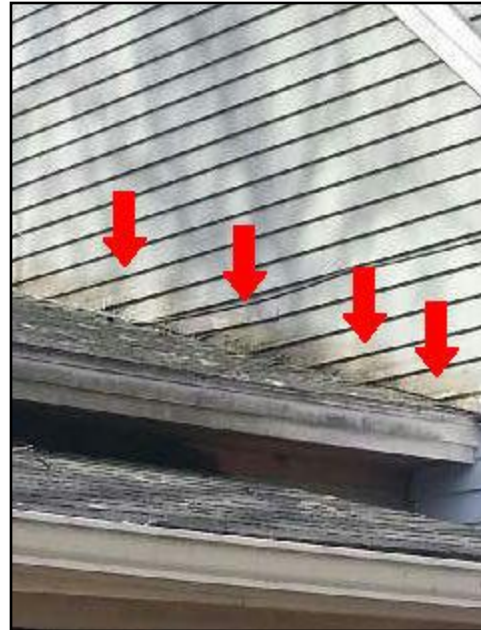
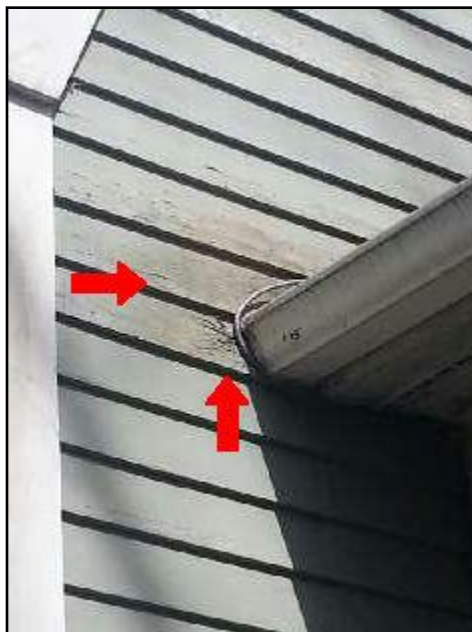
6. Condition: • [Paint or stain - needed](#)

Implication(s): Shortened life expectancy of material

9. Paint or stain - needed

Task: Provide

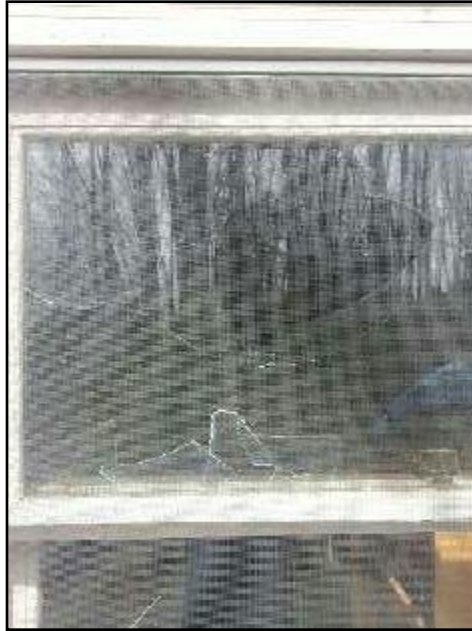
7. Condition: • [Broken](#)

Implication(s): Chance of water entering house | Chance of pests entering house | Increased heating and cooling costs | Reduced comfort

12. Broken

Task: Repair

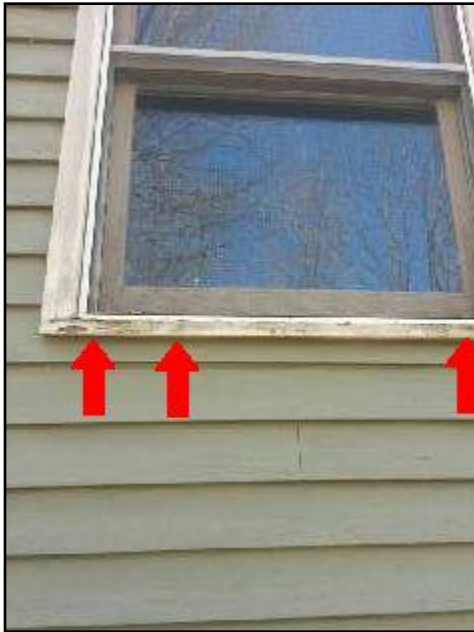
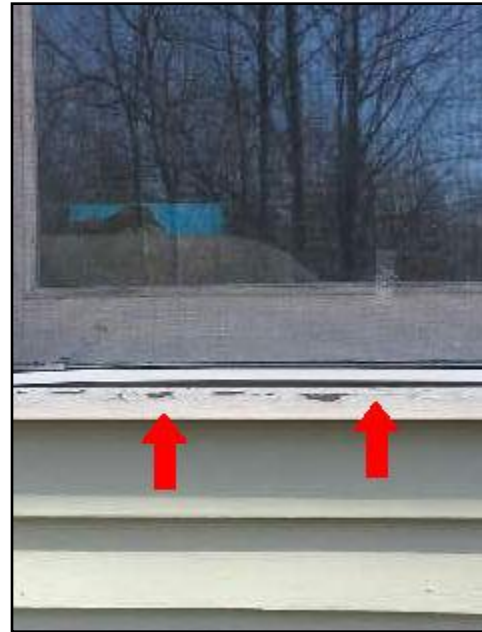
8. Condition: • [Paint or stain needed](#)

Implication(s): Chance of water damage to contents, finishes and/or structure | Material deterioration

13. *Paint or stain needed*

Task: Provide

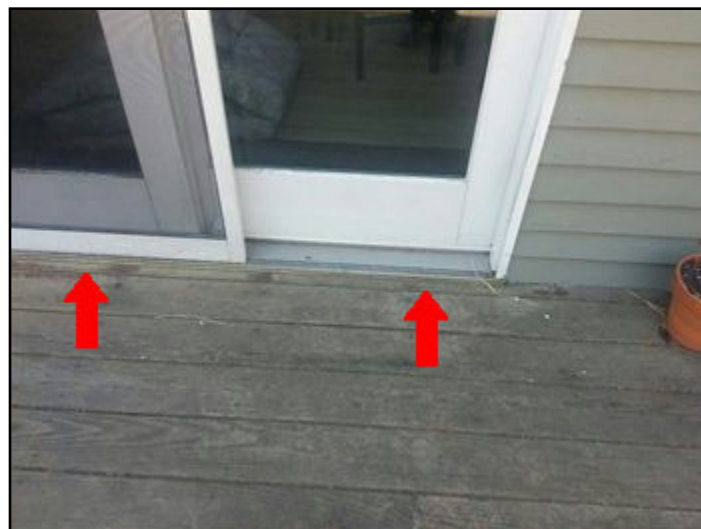
15.

9. Condition: • The deck sliding doors do not have a step up into the house. It is recommended there be a six inch step up where snow and ice can accumulate.

Task: Monitor

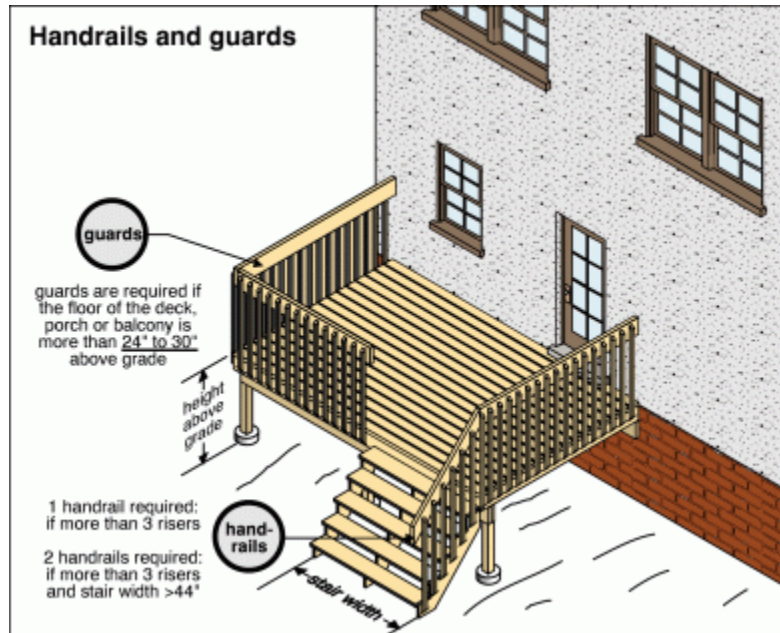
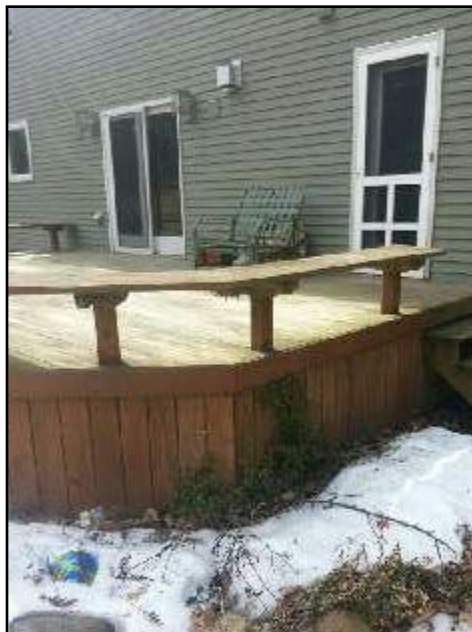
10. Condition: • [Missing](#)

Guardrail's should be provided for any deck 30 inches or higher. The deck height is borderline and not having rails is a safety issue.

Implication(s): Fall hazard

16. Missing

Task: Provide

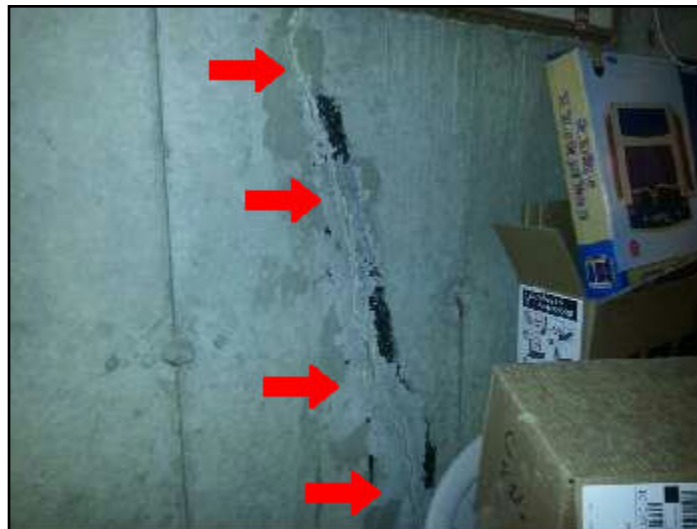
11. Condition: • [Prior repairs](#)

Implication(s): Weakened structure

17. Cracks

Task: Monitor

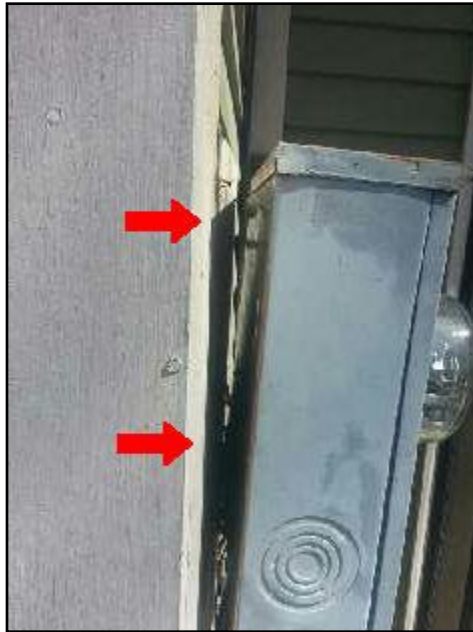
21.

13. **Condition:** • Electric meter loose hanging off wall. Should be attached properly. Electric company is usually responsible for anything prior to entering the home.

Task: Repair

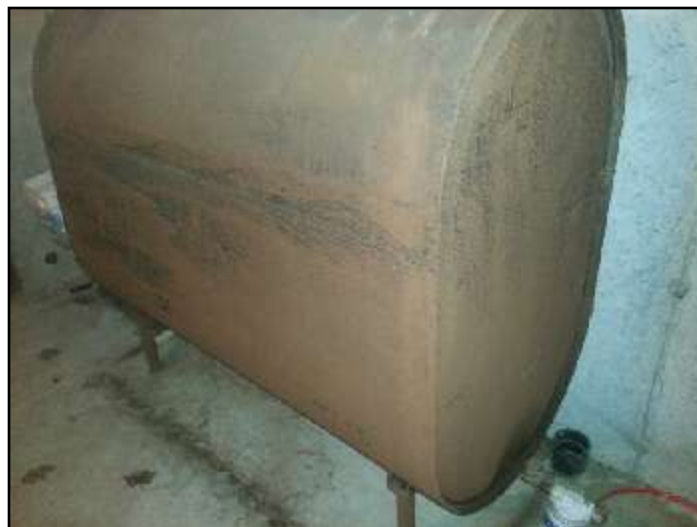
16. Condition: • [Rust](#)

Implication(s): Fire or explosion

32. Rust

Task: Further evaluation

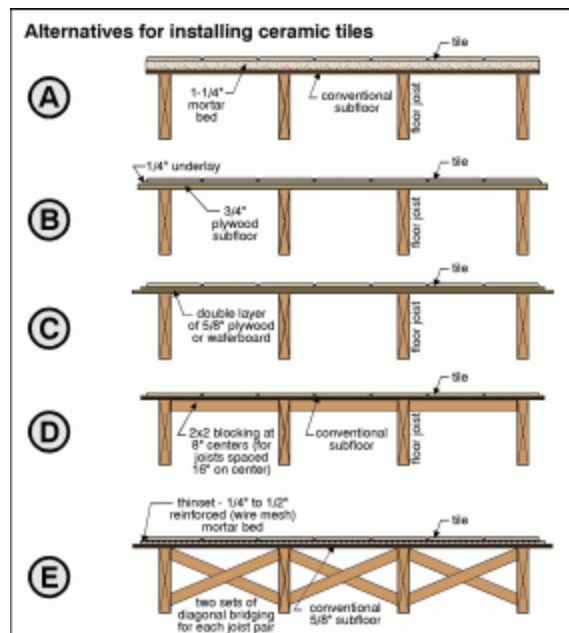
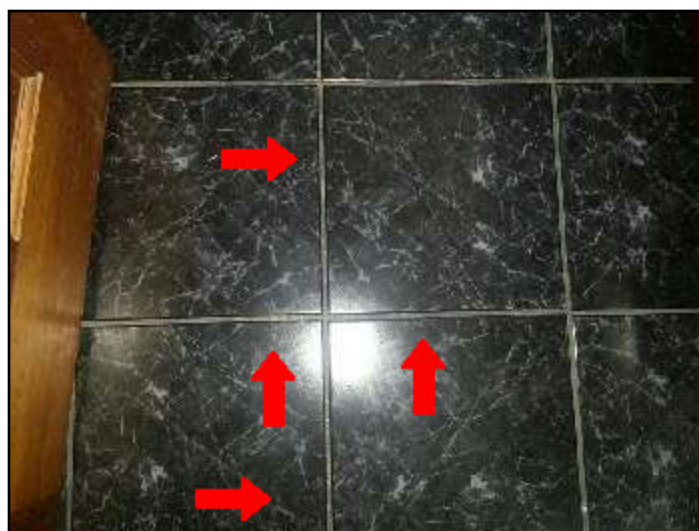
21. Condition: • [Grout missing](#)

Implication(s): Cosmetic defects | Trip or fall hazard

38. Grout missing

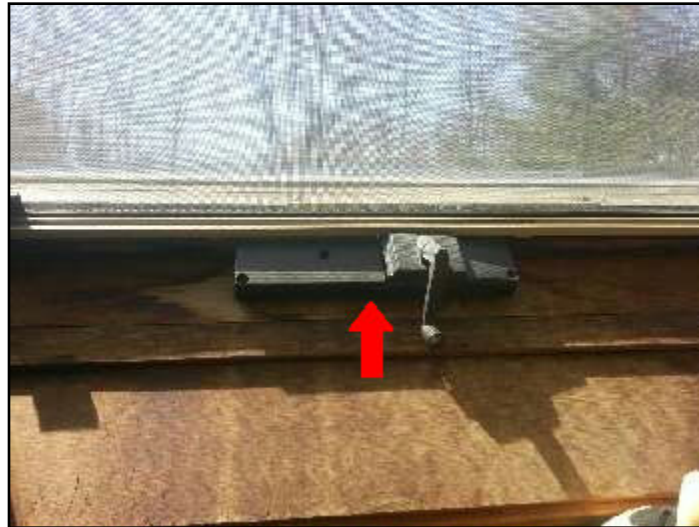
22. Condition: • [Broken](#)

Skylight hardware broken

Implication(s): Cosmetic defects | System inoperative or difficult to operate

39. Broken

Task: Repair or replace

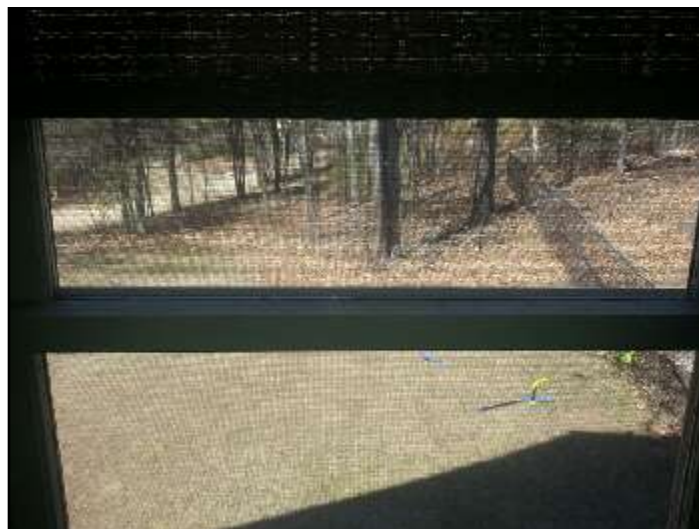
23. Condition: • [Missing](#)

Implication(s): System inoperative or difficult to operate

40. Missing

Task: Provide

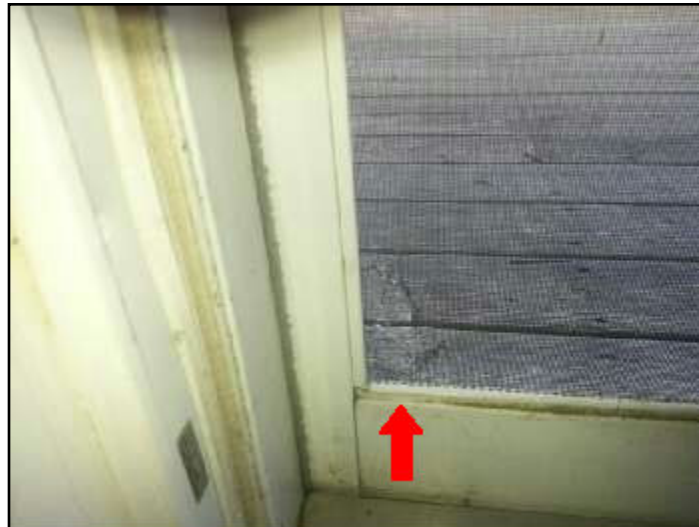
24. Condition: • [Torn](#)

Implication(s): Cosmetic defects | Chance of pests entering house

41. Torn

Task: Repair

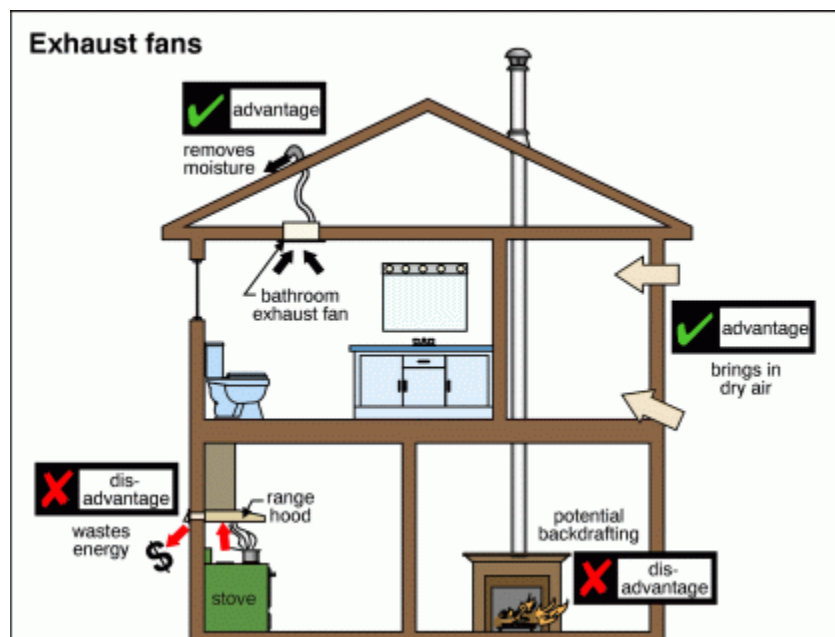
25. Condition: • [Missing](#)

Implication(s): Chance of condensation damage to finishes and/or structure

Task: Provide
